**Flood Control Project Maintenance
Levee Inspections**

Fall 2016 Levee Maintenance Deficiency Summary Report

Sacramento River Basin

Sacramento River West Side Levee District

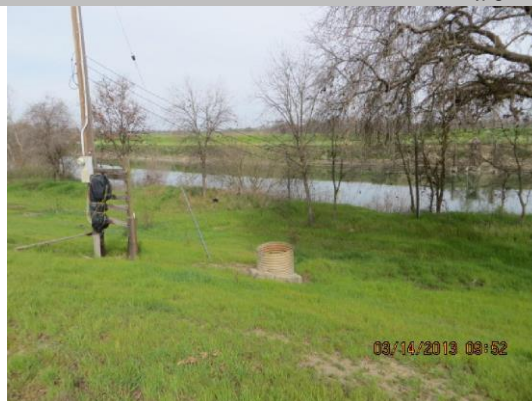
Photo 1 of 2 : UCIP_FA_2016_10265_17486.jpg

LM Start	24.73	Rating **	M	Issue No.	1575
LM End	24.73	Issue Type +	En	Location *	CR
Category	Supplemental			GPS Latitude/Longitude	
				Start	End
Item	DWR UCIP Field Study			39.005097 °	39.005097 °
				-121.816116 °	-121.816116 °
DWR ID					
Comment Code					
Inspector Comment					
FS_ID:10265					
DS_ID:20251					
EP_NO: 9328					
Repair Type: Non-Urgent					
Crossing Status: Found					
UCIP Comments: Appears abandoned. Needs to be abandoned properly.					
FIELD_STRUCT_DESC: 24-inch corrugated metal pipe through levee 20.0 feet below crown. Slide gate in 36-inch corrugated metal riser unit on the waterward slope. 7'X9' Distribution box at toe of the landward slope (ABO. No. 9328, 1960)					
FS Date: 3/14/2013

Slide gate in 36-inch CMP riser on WS slope.

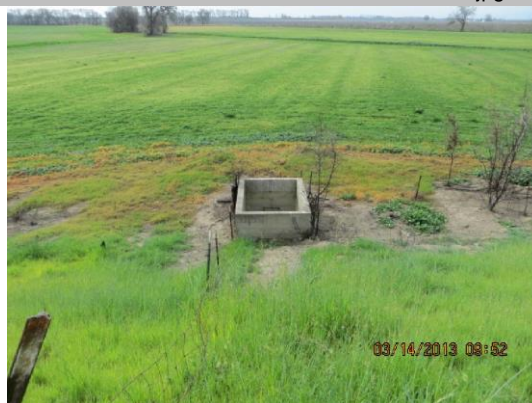
Photo 2 of 2 : UCIP_FA_2016_10265_17485.jpg

LM Start	24.73	Rating **	M	Issue No.	1575 (cont)
LM End	24.73	Issue Type +	En	Location *	CR

7-foot by 9-foot distribution box at LS toe.

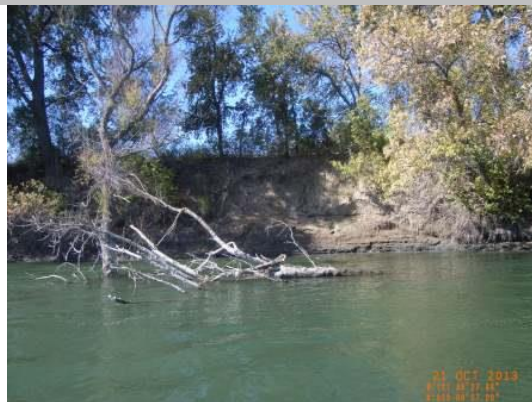
Photo 1 of 1 : FA_2016_NA0016_435_12_20160913_00012.jpg

LM Start	25.75	Rating **	M	Issue No.	12
LM End	25.91	Issue Type +	Ma	Location *	WS
Category	Supplemental			GPS Latitude/Longitude	
				Start	End
Item	2015 USACE Erosion Survey, DRAFT			39.014499 °	39.016401 °
				-121.825880 °	-121.824230 °
DWR ID	DWR_NA0016_01_s_2016_12				
Comment Code					
Inspector Comment					
2008 - Whole bank is eroding, nearly vertical slope with cohesive toe. Bed is very deep along the toe (greater than 30 ft deep at 20 ft from the shore). 2011 - Some new minor erosion. 2015: No observed changes. [2015 Site ID: SAC_118-0_R]

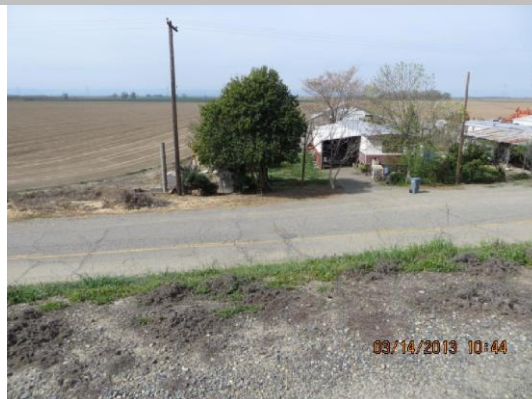
Photo 1 of 2 : UCIP_FA_2016_10285_17532.jpg

LM Start	26.46	Rating **	M	Issue No.	1555
LM End	26.46	Issue Type +	En	Location *	WS
Category	Supplemental			GPS Latitude/Longitude	
				Start	End
Item	DWR UCIP Field Study			39.023842 °	39.023842 °
				-121.823077 °	-121.823077 °
DWR ID					
Comment Code					
Inspector Comment					
FS_ID:10285					
DS_ID:20253					
EP_NO: 9136					
Repair Type: Non-Urgent					
Crossing Status: Found					
UCIP Comments: Pipe appears to be abandoned. Pipe needs to be abandoned properly.					
FIELD_STRUCT_DESC: *ABANDONED* 18-inch steel pipe through levee 3.0 feet below crown. Steel cutoff wall at centerline. Air release valve on the waterward shoulder (Permit No. 9136, 1974). Slide gate in 72-inch diameter CMP riser on LS toe.					
FS Date: 3/14/2013

72-inch CMP riser on LS toe under JP next to tree.

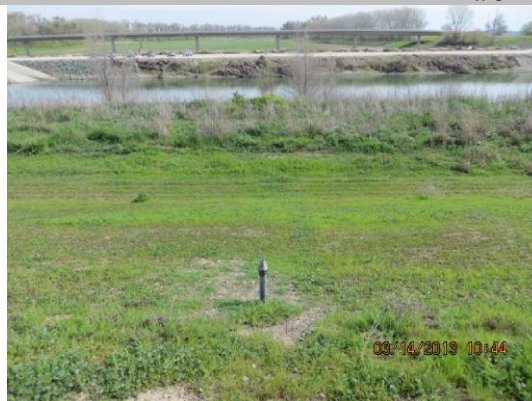
Photo 2 of 2 : UCIP_FA_2016_10285_17531.jpg

Air release valve on WS shoulder.

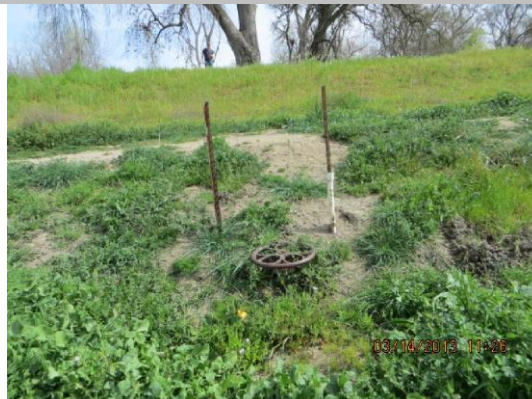
Photo 1 of 2 : UCIP_FA_2016_10289_17543.jpg

LM Start	27.46	Rating **	M	Issue No.	1557
LM End	27.46	Issue Type +	En	Location *	WS
Category	Supplemental			GPS Latitude/Longitude	
				Start	End
Item	DWR UCIP Field Study			39.033767 °	39.033767 °
				-121.833110 °	-121.833110 °
DWR ID					
Comment Code					
Inspector Comment					
FS_ID:10289 DS_ID:20256 EP_NO: 9368 Repair Type: Non-Urgent Crossing Status: Found UCIP Comments: Need to abandon pipe properly. FIELD_STRUCT_DESC: 24-inch steel pipe through levee 16.2 feet below crown (ABO No. 9368, 1960) Pump on the waterward bank. Gate valve on the landward end. Concrete box at the landward toe of the slope. Irrigation well 6 feet from toe of landward slope. Originally included in the 1960 O&M manual with the description standpipe on waterward side. FS Date: 3/14/2013

gate valve off landside toe.

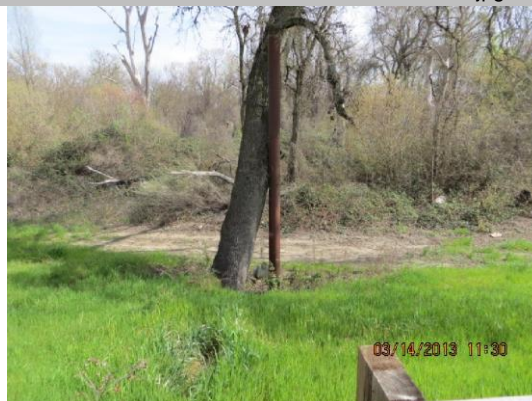
Photo 2 of 2 : UCIP_FA_2016_10289_17542.jpg

steel standpipe on WS toe.

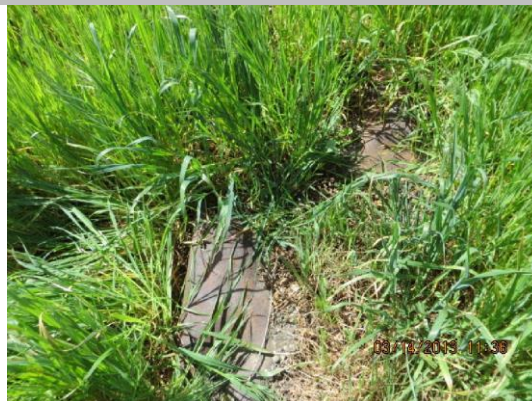
Photo 2 of 2 : UCIP_FA_2016_10290_17544.jpg

FS_ID:10290
DS_ID:20416
EP_NO: N/A
Repair Type: Non-Urgent
Crossing Status: Indicator Found
UCIP Comments: Appears this pipe is abandoned and visible on WS slope in pieces. Need to verify proper abandonment.
FIELD_STRUCT_DESC: *ABANDONED* 24-inch pipe through levee 6.2 feet below crown. Originally included in the 1960 O&M manual.
Pipe debris on WS slope.
FS Date: 3/14/2013

Pipe debris on WS slope.

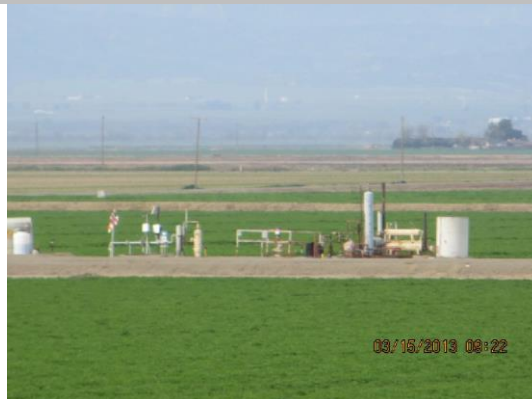
Photo 1 of 1 : UCIP_FA_2016_49833_17563.jpg

Comment Code					
Inspector Comment					
FS_ID:49833 DS_ID:20319 EP_NO: 16632 Repair Type: Non-Urgent Crossing Status: Indicator Found UCIP Comments: 09/01/2016 - No markers on levee. no condition in permit for markers. Pipe is well underneath the levee prism with minimum clearance under the river of 35 feet per permit drawings. (T. Hatch/UCIP) 03/15/2013 No gasline markers on either side of levee. (W. Wylie/UCIP) FIELD_STRUCT_DESC: 4-inch welded steel natural gas pipeline through the levee, 62.0 feet below crown. Crosses under both levees and the Sacramento River channel with a minimum clearance of 35 feet (Permit No. 16632, 1999 - SECI). Gas well visible approximately 1500-feet west of the levee on the landside (LS). FS Date: 9/1/2016

gas well 1500-feet west of this location.

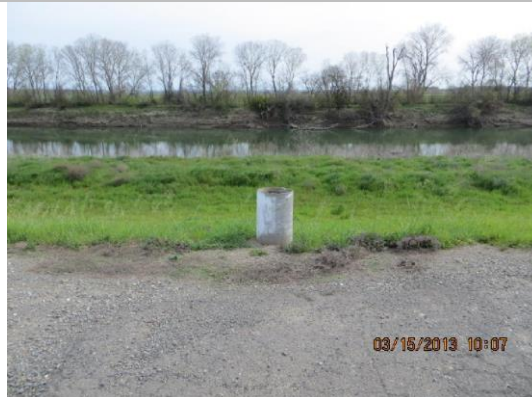
Photo 1 of 2 : UCIP_FA_2016_50042_17587.jpg

FS_ID:50042
DS_ID:20311
EP_NO: 12609
Repair Type: Urgent
Crossing Status: Found
UCIP Comments: 09/23/2016 - pipe outlet still submerged, but visible enough to determine that flap gate is still missing. Appurtenances on the LS of the levee do not appear to be associated with this pipe. There is no visible location for collection of drainage water to go through the outfall. As a result, it does not appear that this pipe is in use. (T. Hatch/UCIP) 09/01/201 - pipe outlet was submerged at time of inspection. Unable to view if flap gate had been replaced. Otherwise, conditions do not appear to be significantly different from previous inspection. (T. Hatch/UCIP) 03/15/201- Flap gate missing from waterward end of pipe. (W. Wylie/UCIP)
FIELD_STRUCT_DESC: 24-inch steel outfall pipe through the levee, 4.1 feet below the crown. There is a siphon breaker in an 18-inch concrete riser on the waterside (WS) shoulder. A flap gate is located on the WS toe. The riverbank has rock protection at the WS toe of the levee (Permit No. 12609, 1979 - Gross).

18-inch concrete riser on WS shoulder.

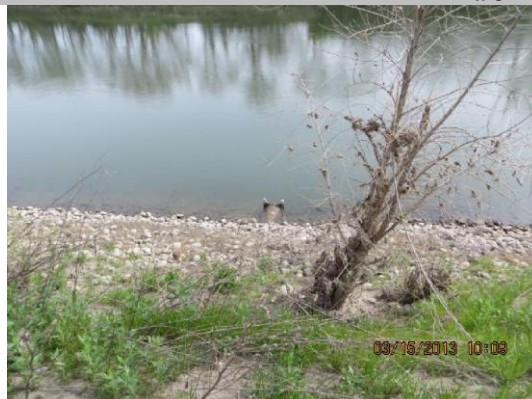
Photo 2 of 2 : UCIP_FA_2016_50042_17586.jpg

Pipe and flap gate at rivers edge

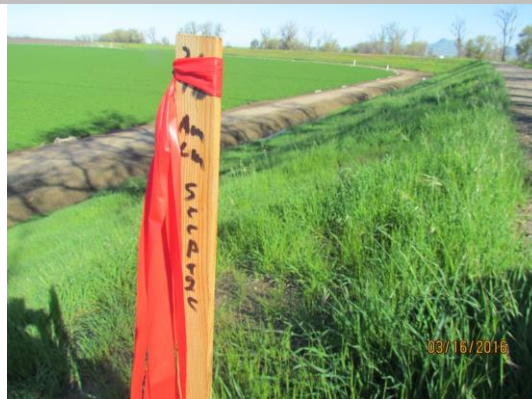
Photo 2 of 2 : FA_2016_NA0016_435_197_20160913_00107.jpg

LM Start	29.58	Rating **	U	Issue No.	197 (cont)
LM End	29.66	Issue Type +	Ob	Location *	LS
Category	Earthen Levee			GPS Latitude/Longitude	
				Start	End
Item	Seepage / Sandboils			39.061709 °	39.062799 °
				-121.839838 °	-121.839564 °
DWR ID	DWR_NA0016_01_s_2016_197				
Comment Code					
Inspector Comment					
Seepage area has been staked and noted by LMA. Monitor seepage site.

Monitoring stake is on the waterward side of the levee. Spring 2016.

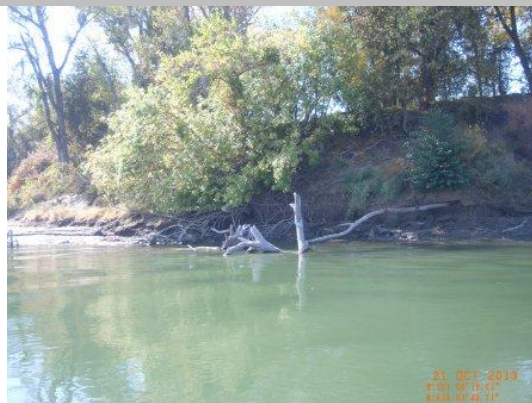
Photo 1 of 1 : FA_2016_NA0016_435_2_20160913_00002.jpg

LM Start	29.69	Rating **	A/W	Issue No.	2
LM End	29.73	Issue Type +	Ma	Location *	WS
Category	Supplemental			GPS Latitude/Longitude	
				Start	End
Item	2015 USACE Erosion Survey, DRAFT			39.063209 °	39.063997 °
				-121.838927 °	-121.839335 °
DWR ID	DWR_NA0016_01_s_2016_2				
Comment Code					
Inspector Comment					
1997 - Mass failure of the lower cohesive bank and toe. 2000 - Still eroding, steeply dipping foresets in the toe are falling off. 2010 - Some new erosion and some new deposition. Eddy current off the upstream rock. 2011 - Still plenty of berm left. 2015: No observed changes. [2015 Site ID: SAC_122-0_R]

USACE 2013 Photo #1

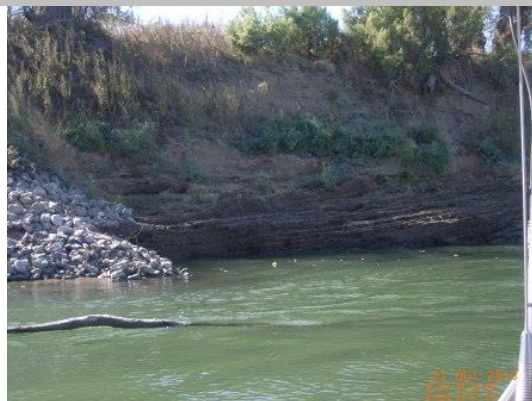
Photo 1 of 1 : FA_2016_NA0016_435_13_20160913_00013.jpg

LM Start	29.96	Rating **	M	Issue No.	13
LM End	30.00	Issue Type +	Ma	Location *	WS
Category	Supplemental			GPS Latitude/Longitude	
				Start	End
Item	2015 USACE Erosion Survey, DRAFT			39.065886 °	39.066287 °
				-121.842950 °	-121.843602 °
DWR ID	DWR_NA0016_01_s _ 2016_13				
Comment Code					
Inspector Comment					
2002 - Upstream end has recent slope failure and exposure of tree roots. 2003 - Some new minor slope erosion with new snags on the bank. 2004 - Appears a little worse. 2005 - Scallop in bank at the upstream end looks worse. 2009 - Minimal new erosion, Berm width is still large, but one large event or one fallen tree and it could go fast. 2010 - New erosion, bank is nearly all vertical from slumping. Site looks bad. 2011 - Site continues to look bad. 2012 - Minor new erosion. 2015: Undermining of toe rock. [2015 Site ID: SAC_122-3_R]

USACE 2013 Photo #1

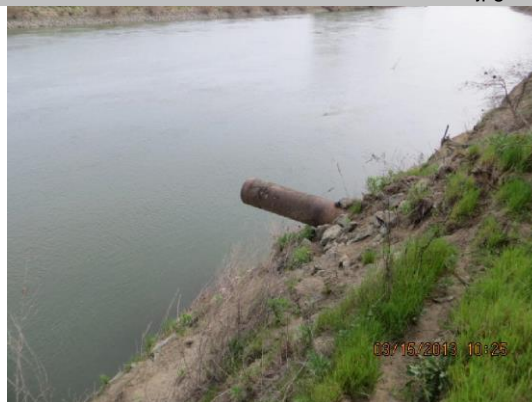
Photo 1 of 2 : UCIP_FA_2016_10325_17591.jpg

LM Start	30.08	Rating **	M	Issue No.	1560
LM End	30.08	Issue Type +	En	Location *	WS
Category	Supplemental			GPS Latitude/Longitude	
				Start	End
Item	DWR UCIP Field Study			39.066749 °	39.066749 °
				-121.844987 °	-121.844987 °
DWR ID					
Comment Code					
Inspector Comment					
FS_ID:10325 DS_ID:20317 EP_NO: 14495 Repair Type: Non-Urgent Crossing Status: Found UCIP Comments: Pipe may need flap gate at water side. FIELD_STRUCT_DESC: 22-inch steel storm drain pipe through levee 3.8 feet below crown. Pipe extends from existing pumphouse located at the landward toe through the levee to the low water channel Siphon breaker in 24-inch CMP riser on LS shoulder. (Permit No. 14495, 1987). Replaced 12-inch and 16-inch pipes installed under Permit No. 9358. FS Date: 3/15/2013

24-inch pipe at rivers edge

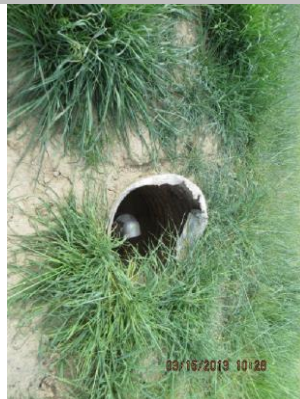
Photo 2 of 2 : UCIP_FA_2016_10325_17590.jpg

LM Start	30.08	Rating **	M	Issue No.	1560 (cont)
LM End	30.08	Issue Type +	En	Location *	WS
Category	Supplemental			GPS Latitude/Longitude	
				Start	End
Item	DWR UCIP Field Study			39.066749 °	39.066749 °
				-121.844987 °	-121.844987 °
DWR ID					
Comment Code					
Inspector Comment					
FS_ID:10325 DS_ID:20317 EP_NO: 14495 Repair Type: Non-Urgent Crossing Status: Found UCIP Comments: Pipe may need flap gate at water side. FIELD_STRUCT_DESC: 22-inch steel storm drain pipe through levee 3.8 feet below crown. Pipe extends from existing pumphouse located at the landward toe through the levee to the low water channel Siphon breaker in 24-inch CMP riser on LS shoulder. (Permit No. 14495, 1987). Replaced 12-inch and 16-inch pipes installed under Permit No. 9358. FS Date: 3/15/2013

Siphon breaker in 24-inch cmp on LS shoulder.

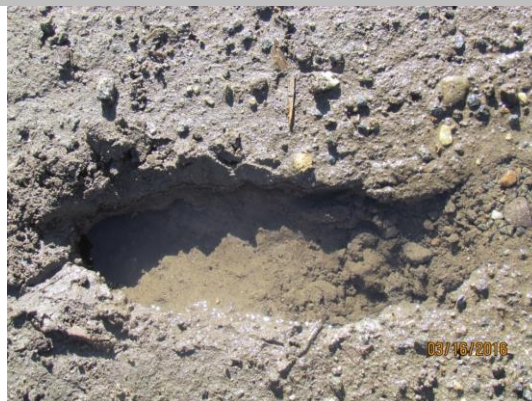
Photo 1 of 3 : FA_2016_NA0016_435_201_20160913_00111.jpg

LM Start	30.24	Rating **	U	Issue No.	201 (cont)
LM End	30.24	Issue Type +	Ob	Location *	LS

Boil has clear water running through. Spring 2016.

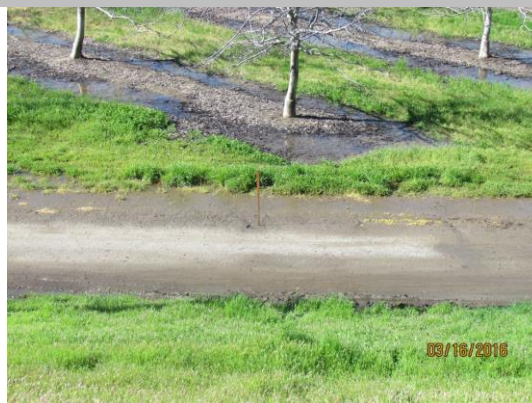
Photo 2 of 3 : FA_2016_NA0016_435_201_20160913_00112.jpg

Perspective view of the boil at the toe road on the landward side of the levee. Spring 2016.

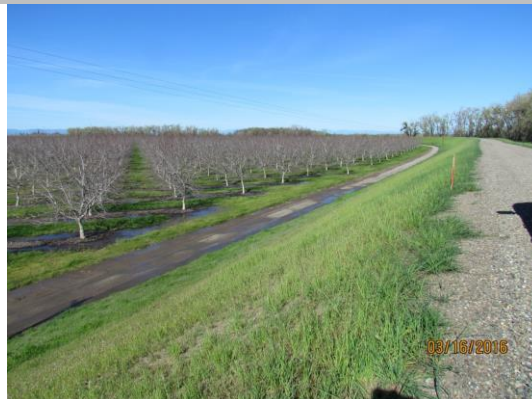
Photo 1 of 2 : FA_2016_NA0016_435_200_20160913_00109.jpg

LM Start	30.25	Rating **	U	Issue No.	200
LM End	30.25	Issue Type +	Ob	Location *	LS
Category	Earthen Levee			GPS Latitude/Longitude	
				Start	End
Item	Seepage / Sandboils			39.068542 °	39.068542 °
				-121.847131 °	-121.847131 °
DWR ID	DWR_NA0016_01_s_2016_200				
Comment Code					
Inspector Comment					
LMA has stakes on the levee monitoring seepage site.

View of the seepage on the landward side of the levee looking upstream. Spring 2016.

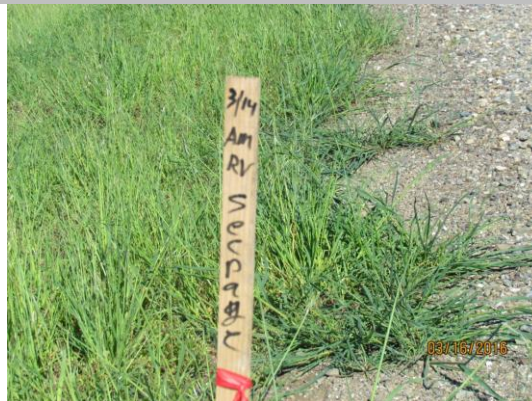
Photo 2 of 2 : FA_2016_NA0016_435_200_20160913_00110.jpg

LM Start	30.25	Rating **	U	Issue No.	200 (cont)
LM End	30.25	Issue Type +	Ob	Location *	LS

Stake is used to monitor seepage. Spring 2016.

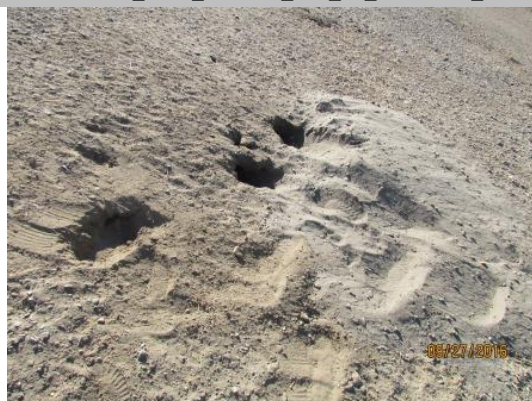
Photo 1 of 1 : FA_2016_NA0016_435_79_20160929_00243.jpg

LM Start	30.28	Rating **	U	Issue No.	79
LM End	30.28	Issue Type +	Ma	Location *	LS
Category	Earthen Levee			GPS Latitude/Longitude	
				Start	End
Item	Animal Control			39.068949 °	39.068949 °
				-121.847551 °	-121.847551 °
DWR ID	DWR_NA0016_01_f_2016_79				
Comment Code					
A1 : Exterminate rodents and backfill and compact or grout burrows.					
Inspector Comment

Burrows on landside slope. Most likely fox holes. Fall 2016 inspection.

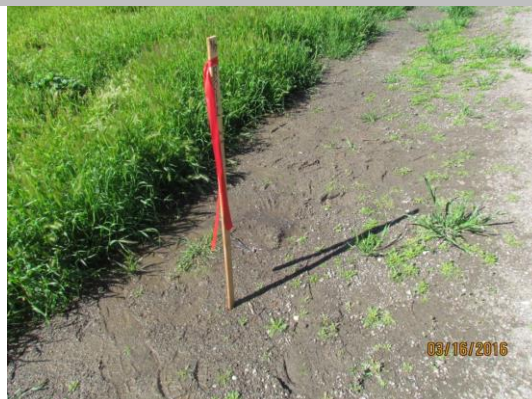
Photo 1 of 3 : FA_2016_NA0016_435_202_20160913_00114.jpg

LM Start	30.46	Rating **	A	Issue No.	202
LM End	30.46	Issue Type +	Ob	Location *	LS
Category	Earthen Levee			GPS Latitude/Longitude	
				Start	End
Item	Seepage / Sandboils			39.070673 °	39.070673 °
				-121.849935 °	-121.849935 °
DWR ID	DWR_NA0016_01_s_2016_202				
Comment Code					
Inspector Comment					
Sandboil about 2 inches wide is spitting out material. LMA has sandbagged the boil.

View of the monitoring stake and boil at the toe of the levee on the landward side. Spring 2016.

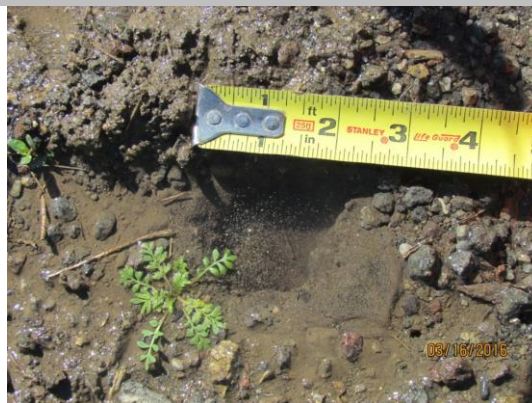
Photo 2 of 3 : FA_2016_NA0016_435_202_20160913_00115.jpg

Boil is about 2 inches wide. Spring 2016.

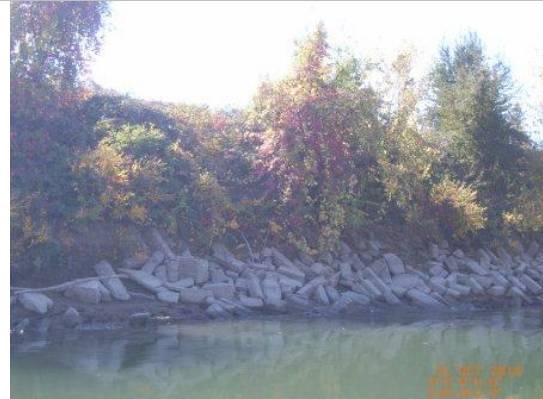
Photo 1 of 1 : FA_2016_NA0016_435_17_20160913_00016.jpg

LM Start	31.43	Rating **	M	Issue No.	17
LM End	31.45	Issue Type +	Ma	Location *	WS
Category	Supplemental			GPS Latitude/Longitude	
				Start	End
Item	2015 USACE Erosion Survey, DRAFT			39.067004 °	39.066901 °
				-121.866913 °	-121.867322 °
DWR ID	DWR_NA0016_01_s_2016_17				
Comment Code					
Inspector Comment					
1997 - Erosion into the levee section; old concrete rubble loss at toe; transition between the rock upstream and the cobble downstream. 2000 - Cohesive bench with concrete slabs on top; 25 ft deep scour hole on the downstream end. 2015: No observed changes. [2015 Site ID: SAC_123-7_R]

USACE 2013 Photo #1

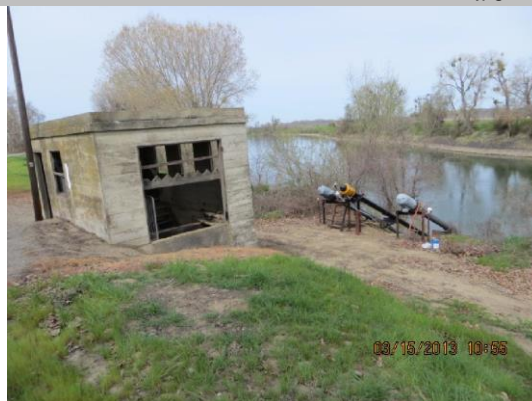
Photo 1 of 2 : UCIP_FA_2016_11543_18942.jpg

FS_ID:11543
DS_ID:20262
EP_NO: 9338
Repair Type: Non-Urgent
Crossing Status: Found
UCIP Comments: Pipe leaking at intake pipe on rivers edge below pump
FIELD_STRUCT_DESC: 24-inch steel pipe through levee 24.0 feet below crown (ABO No. 9338, 1960). Slide gate in abandoned concrete pump house on the waterward slope. Three slant pumps mounted on pile structure on the waterward bank. 30-inch concrete pipe under the highway on the landside. 48-inch steel riser on the landside of highway. Overhead high tower power line crosses the levee. Power line has been run underground to service box on waterward shoulder at L.M. 32.01. Ramps on both slopes. Originally included in the 1960 O&M manual. FS Date: 3/15/2013

Concrete block house with slide gate inside.

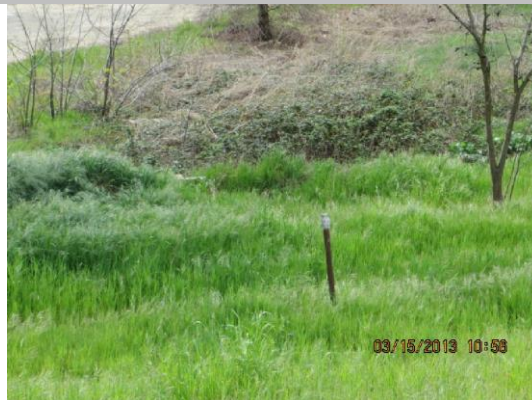
Photo 2 of 2 : UCIP_FA_2016_11543_18941.jpg

Siphon breaker on LS toe.

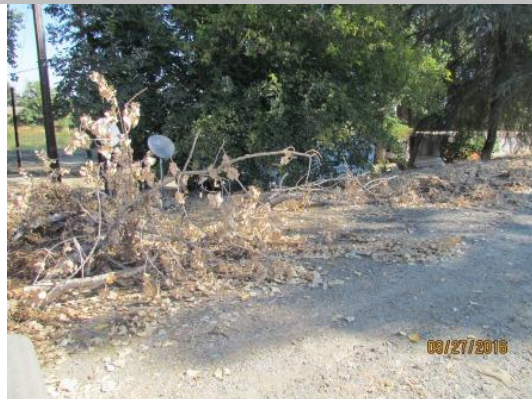
Photo 1 of 1 : FA_2016_NA0016_435_81_20160929_00246.jpg

LM Start	32.07	Rating **	M	Issue No.	81
LM End	32.09	Issue Type +	En	Location *	WS
Category	Earthen Levee			GPS Latitude/Longitude	
				Start	End
Item	Encroachments			39.069439 °	39.069510 °
				-121.877410 °	-121.877728 °
DWR ID	DWR_NA0016_01_f_2016_81				
Comment Code					
DE : Debris					
Inspector Comment

View of prunings and debris on WS slope near encroaching buildings.
Fall 2016 inspection.

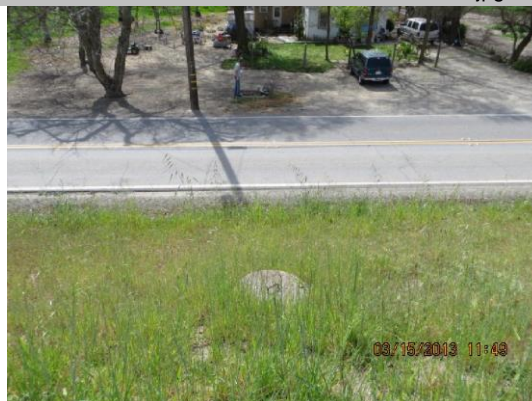
Photo 1 of 2 : UCIP_FA_2016_10364_17645.jpg

LM Start	32.27	Rating **	M	Issue No.	1563
LM End	32.27	Issue Type +	En	Location *	WS
Category	Supplemental			GPS Latitude/Longitude	
				Start	End
Item	DWR UCIP Field Study			39.069857 °	39.069857 °
				-121.880923 °	-121.880923 °
DWR ID					
Comment Code					
Inspector Comment					
FS_ID:10364					
DS_ID:20304					
EP_NO: 9374					
Repair Type: Non-Urgent					
Crossing Status: Found					
UCIP Comments: Need to verify type of abandonment					
FIELD_STRUCT_DESC: 2 of 4: *Abandoned* 4-inch pipe through levee					
6.5 feet below crown. Gate valve on the waterward end. Siphon breaker					
in 24-inch corrugated metal riser unit on the landward slope. 4X4-					
concrete distribution box on south side of highway 45 at LS toe. (ABO					
No. 9374, 1960). Originally included in the 1960 O&M manual.					
FS Date: 3/15/2013

Siphon Breaker in 25-inch CMP riser on LS slope with 4X4 concrete box
off LS toe.

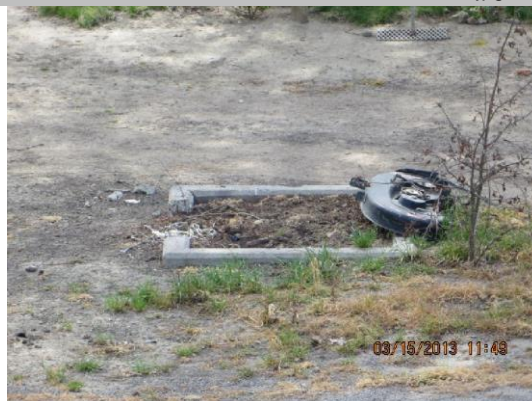
Photo 2 of 2 : UCIP_FA_2016_10364_17644.jpg

LM Start	32.27	Rating **	M	Issue No.	1563 (cont)
LM End	32.27	Issue Type +	En	Location *	WS
Category	Supplemental			GPS Latitude/Longitude	
				Start	End
Item	DWR UCIP Field Study			39.069857 °	39.069857 °
				-121.880923 °	-121.880923 °
DWR ID					
Comment Code					
Inspector Comment					
FS_ID:10364					
DS_ID:20304					
EP_NO: 9374					
Repair Type: Non-Urgent					
Crossing Status: Found					
UCIP Comments: Need to verify type of abandonment					
FIELD_STRUCT_DESC: 2 of 4: *Abandoned* 4-inch pipe through levee					
6.5 feet below crown. Gate valve on the waterward end. Siphon breaker					
in 24-inch corrugated metal riser unit on the landward slope. 4X4-					
concrete distribution box on south side of highway 45 at LS toe. (ABO					
No. 9374, 1960). Originally included in the 1960 O&M manual.					
FS Date: 3/15/2013

4X4 concrete box off LS toe.

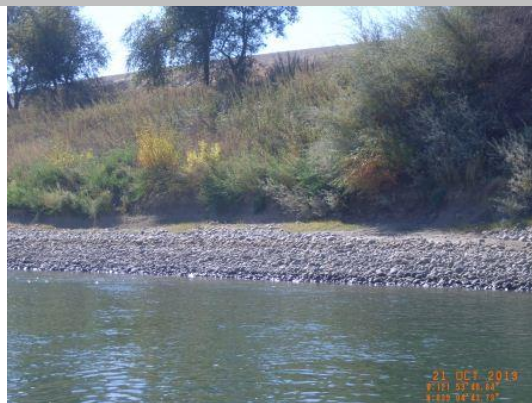
Photo 1 of 1 : FA_2016_NA0016_435_5_20160913_00005.jpg

LM Start	33.29	Rating **	M	Issue No.	5
LM End	33.37	Issue Type +	Ma	Location *	WS
Category	Supplemental			GPS Latitude/Longitude	
				Start	End
Item	2015 USACE Erosion Survey, DRAFT			39.078340 °	39.079351 °
				-121.894656 °	-121.895317 °
DWR ID	DWR_NA0016_01_s_2016_5				
Comment Code					
Inspector Comment					
2008 - Slow erosion of the hard toe. 2010 - Cobble rubble is failing, erosion is into the toe of the levee, with vertical slumping. 2012 - Site appears to be relatively stable. 2013 - New animal holes. 2015: No observed changes. [2015 Site ID: SAC_125-6_R]

USACE 2013 Photo #1

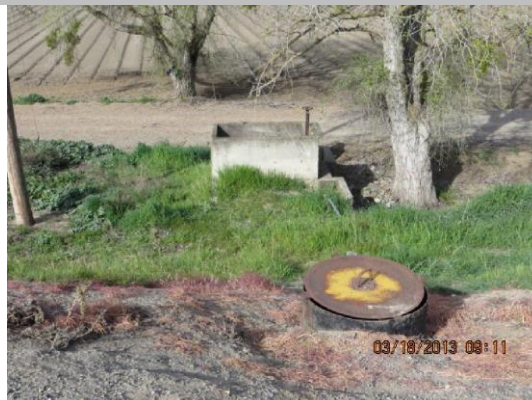
Photo 2 of 2 : UCIP_FA_2016_10403_17661.jpg

siphon breaker in 36-inch steel riser on LS slope with concrete distribution box on LS toe.

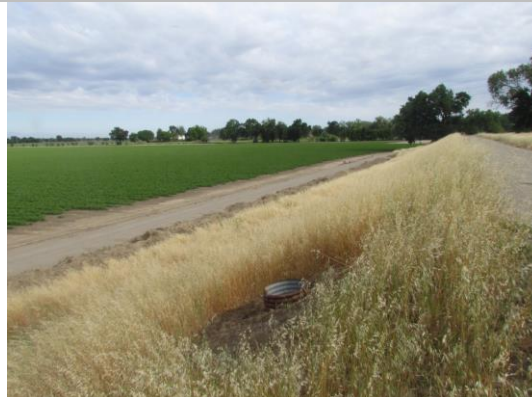
Photo 1 of 1 : FA_2016_NA0016_435_100_20160913_00043.jpg

LM Start	34.01	Rating **	M	Issue No.	100
LM End	34.07	Issue Type +	En	Location *	LS
Category	Earthen Levee			GPS Latitude/Longitude	
				Start	End
Item	Encroachments			39.087176 °	39.088099 °
				-121.896480 °	-121.896498 °
DWR ID	DWR_NA0016_01_s_2015_100				
Comment Code					
DT : Ditch					
Inspector Comment

View of the ditch at the landward side of the levee looking upstream. Spring 2015.

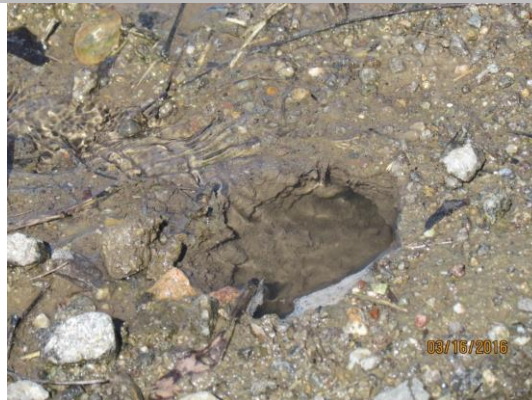
Photo 1 of 2 : FA_2016_NA0016_435_208_20160913_00118.jpg

LM Start	34.15	Rating **	U	Issue No.	208
LM End	34.15	Issue Type +	Ob	Location *	LS
Category	Earthen Levee			GPS Latitude/Longitude	
				Start	End
Item	Seepage / Sandboils			39.089243 °	39.089243 °
				-121.896262 °	-121.896262 °
DWR ID	DWR_NA0016_01_s_2016_208				
Comment Code					
Inspector Comment					
Clear water. Boil about 5 inches wide. Also a seepage area.

Boil has clear water coming out of the hole. Spring 2016.

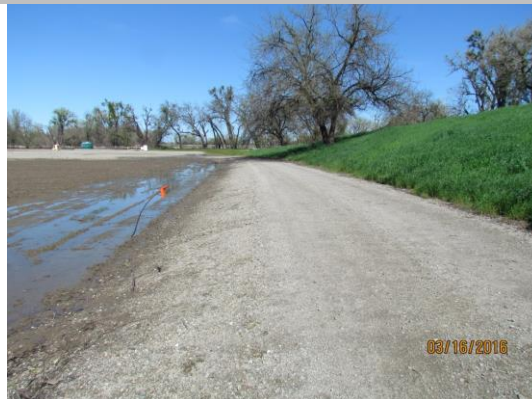
Photo 2 of 2 : FA_2016_NA0016_435_208_20160913_00119.jpg

LM Start	34.15	Rating **	U	Issue No.	208 (cont)	
LM End	34.15	Issue Type +	Ob	Location *	LS	
Category	Earthen Levee			GPS Latitude/Longitude		
				Start		End
Item	Seepage / Sandboils			39.089243 °	39.089243 °	
				-121.896262 °	-121.896262 °	
DWR ID	DWR_NA0016_01_s_ 2016_208					
Comment Code						
Inspector Comment						
Clear water. Boil about 5 inches wide. Also a seepage area.

View of the seepage and boil at the toe of the levee on the landward side looking upstream. Spring 2016.

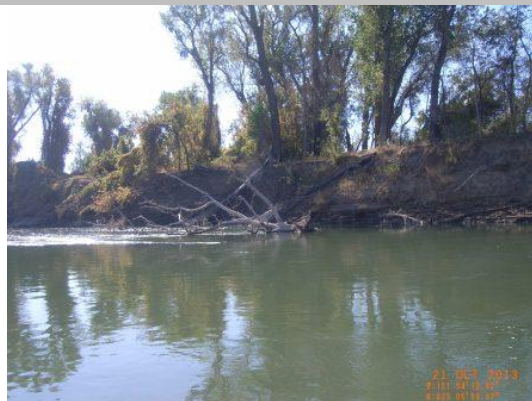
Photo 1 of 1 : FA_2016_NA0016_435_1_20160913_00001.jpg

LM Start	35.23	Rating **	A/W	Issue No.	1
LM End	35.33	Issue Type +	Ma	Location *	WS
Category	Supplemental			GPS Latitude/Longitude	
				Start	End
Item	2015 USACE Erosion Survey, DRAFT			39.099482 °	39.100836 °
				-121.903430 °	-121.904320 °
DWR ID	DWR_NA0016_01_s_2016_1				
Comment Code					
Inspector Comment					
1997 - Major scour off the downstream end of existing rock, creating a scour pocket where the levee starts diverging from the bankline. 2000 - Some minor erosion, 20 ft deep hole at downstream end. 2004 - Small amount of new erosion. 2010 - Bad transition off downstream end of rock revetment, some new erosion. 2012 - Site extended downstream, minor new erosion. 2013 - Minor new erosion. 2015: No observed changes. [2015 Site ID: SAC_127-9_R]

USACE 2013 Photo #1

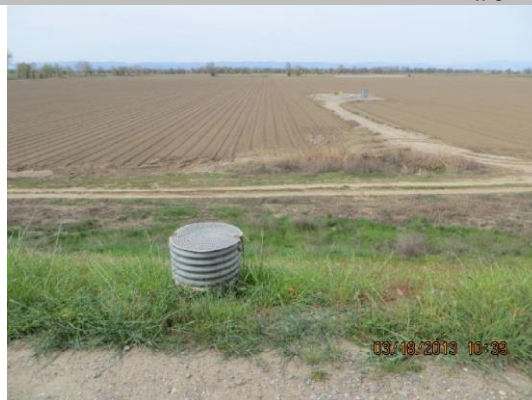
Photo 1 of 1 : UCIP_FA_2016_10424_17700.jpg

LM Start	35.56	Rating **	M	Issue No.	1571
LM End	35.56	Issue Type +	En	Location *	WS
Category	Supplemental			GPS Latitude/Longitude	
				Start	End
Item	DWR UCIP Field Study			39.103533 °	39.103533 °
				-121.906814 °	-121.906814 °
DWR ID					
Comment Code					
Inspector Comment					
FS_ID:10424					
DS_ID:20273					
EP_NO: 9364A					
Repair Type: Non-Urgent					
Crossing Status: Found					
UCIP Comments: Need to verify type of abandonment.					
FIELD_STRUCT_DESC: 3 of 4: 18-inch steel pipe through levee 16.0					
feet below crown. Metal cutoff wall. Gate valve on the waterward bank.					
Siphon breaker in 24-inch corrugated metal riser unit on the landward					
shoulder. (ABO No. 9364A, 1960). Originally included in the 1960 O&M					
manual.					
FS Date: 3/18/2013

Siphon breaker in 24-inch CMP riser on LS shoulder.

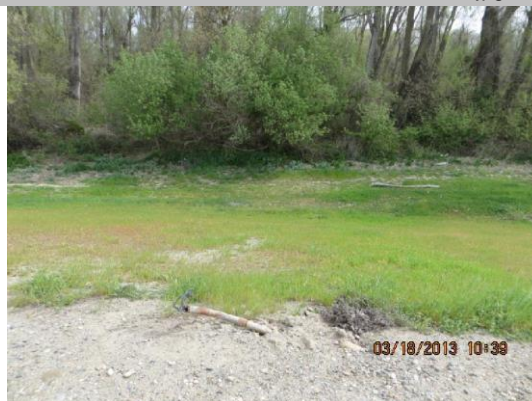
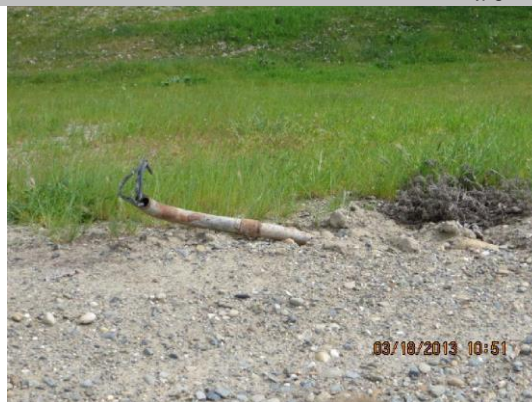
LM Start	35.56	Rating **	M	Issue No.	1572
LM End	35.56	Issue Type +	En	Location *	WS
Category	Supplemental			GPS Latitude/Longitude	
				Start	End
Item	DWR UCIP Field Study			39.103533 °	39.103533 °
				-121.906814 °	-121.906814 °
DWR ID					
Comment Code					
Inspector Comment					
FS_ID:10425					
DS_ID:20398					
EP_NO: 9364					
Repair Type: Non-Urgent					
Crossing Status: Found					
UCIP Comments: Remove abandoned pipe from levee.					
FIELD_STRUCT_DESC: 4 of 4: *Abandoned* 1.25-inch conduit through					
levee 3.0 feet below crown (ABO No. 9364A).					
FS Date: 3/18/2013

Electrical conduit on WS shoulder.

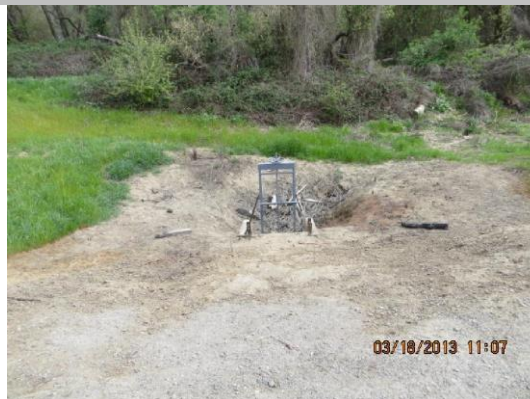
Photo 1 of 2 : UCIP_FA_2016_10426_17705.jpg

LM Start	36.15	Rating **	M	Issue No.	1573
LM End	36.15	Issue Type +	En	Location *	LS
Category	Supplemental			GPS Latitude/Longitude	
				Start	End
Item	DWR UCIP Field Study			39.111233 °	39.111233 °
				-121.911450 °	-121.911450 °
DWR ID					
Comment Code					
Inspector Comment					
FS_ID:10426 DS_ID:20345 EP_NO: 9374 Repair Type: Non-Urgent Crossing Status: Found UCIP Comments: Verify if pipe is abandoned with landowner and remove or abandon properly if necessary. FIELD_STRUCT_DESC: *ABANDONED* 3 of 3: 24-inch concrete encased steel drain pipe through levee 17.0 feet below crown. Slide gate on concrete headwalls in waterward end, walkway to control gate and gate valve on landward end (ABO No. 9374, 1960). Originally included in the 1960 O&M manual. FS Date: 3/18/2013

Slide gate on WS toe.

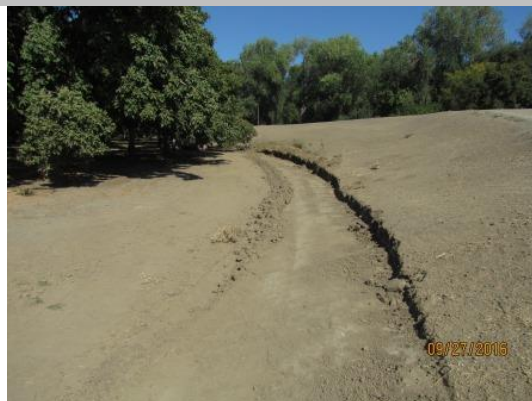
Photo 1 of 1 : FA_2016_NA0016_435_94_20160929_00249.jpg

LM Start	36.16	Rating **	M	Issue No.	94
LM End	36.32	Issue Type +	En	Location *	LS
Category	Earthen Levee			GPS Latitude/Longitude	
				Start	End
Item	Encroachments			39.111405 °	39.113321 °
				-121.911579 °	-121.913226 °
DWR ID	DWR_NA0016_01_f_2016_94				
Comment Code					
AT : Agricultural tilling					
Inspector Comment					
LMA contacted the property owner to eliminate this issue. LMA may provide pictures of this site after issue is corrected.

Levee toe on landward side has been cut due to agricultural work. Fall 2016 inspection.

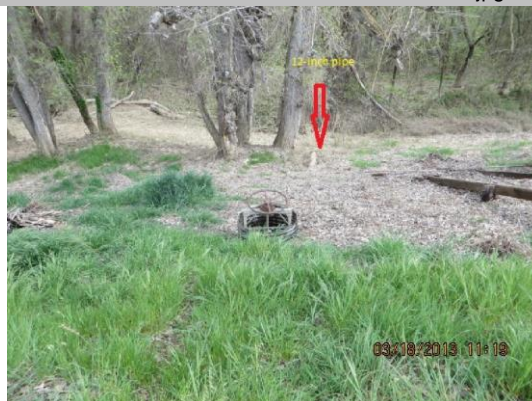
Photo 1 of 2 : UCIP_FA_2016_10444_17725.jpg

Comment Code					
Inspector Comment					
FS_ID:10444					
DS_ID:20274					
EP_NO: 9374					
Repair Type: Non-Urgent					
Crossing Status: Found					
UCIP Comments: Pipe should be abandoned properly.					
FIELD_STRUCT_DESC: 4 of 4: 24-inch corrugated metal pipe through levee 15.5 feet below crown (ABO No. 9374, 1974). Two corrugated metal cutoff walls. Slide gate in 36-inch corrugated metal riser unit on the waterward slope. Pump house with no connection on waterward bank. 12-inch steel pipe with steel plate over end at WS toe (likely pump connection point). 6-foot diameter concrete riser on LS toe. Skid rails mounted on wood piling on the waterward slope. Department of Water Resources B.M. SR 47 on top of concrete anchor post on the waterward shoulder. Power pole and meter box on the waterward shoulder. Switch panel in metal house on the waterward slope. Concrete standpipe on the landward side. Overhead power line crosses the levee to service pole.

36-inch CMP riser with slide gate on WS slope with 12-inch pipe at Toe.

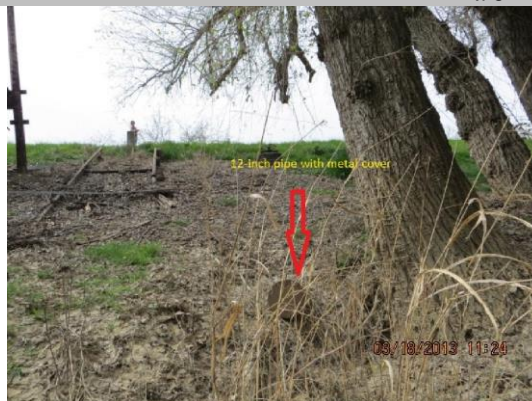
Photo 2 of 2 : UCIP_FA_2016_10444_17724.jpg

Item	DWR UCIP Field Study			39.112377 °	39.112377 °	
				-121.912286 °	-121.912286 °	
DWR ID						
Comment Code						
Inspector Comment						
FS_ID:10444 DS_ID:20274 EP_NO: 9374 Repair Type: Non-Urgent Crossing Status: Found UCIP Comments: Pipe should be abandoned properly. FIELD_STRUCT_DESC: 4 of 4: 24-inch corrugated metal pipe through levee 15.5 feet below crown (ABO No. 9374, 1974). Two corrugated metal cutoff walls. Slide gate in 36-inch corrugated metal riser unit on the waterward slope. Pump house with no connection on waterward bank. 12-inch steel pipe with steel plate over end at WS toe (likely pump connection point). 6-foot diameter concrete riser on LS toe. Skid rails mounted on wood piling on the waterward slope. Department of Water Resources B.M. SR 47 on top of concrete anchor post on the waterward shoulder. Power pole and meter box on the waterward shoulder. Switch panel in metal house on the waterward slope. Concrete standpipe on the landward side. Overhead power line crosses the levee to service pole. FS Date: 3/18/2013 7:51:00 AM

Wooden ramp and 2-inch pump connection at WS toe.

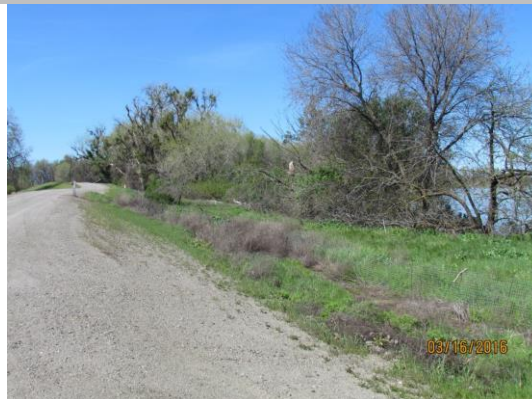
Photo 1 of 2 : FA_2016_NA0016_435_33_20160913_00027.jpg

LM Start	37.07	Rating **	A/W	Issue No.	33
LM End	37.15	Issue Type +	Ob	Location *	WS
Category	Earthen Levee			GPS Latitude/Longitude	
				Start	End
Item	Vegetation			39.121003 °	39.121547 °
				-121.919888 °	-121.921278 °
DWR ID	DWR_NA0016_01_s_2012_33				
Comment Code					
V8 : Environmental Requirements.					
Inspector Comment					
Revegetation site is fenced off.

View of the revegetation site on the waterward berm of the levee looking upstream. Spring 2016.

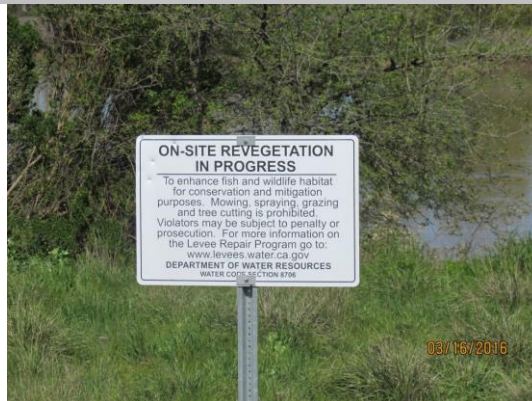
Photo 2 of 2 : FA_2016_NA0016_435_33_20160913_00028.jpg

Sign stating the revegetation site. Spring 2016.

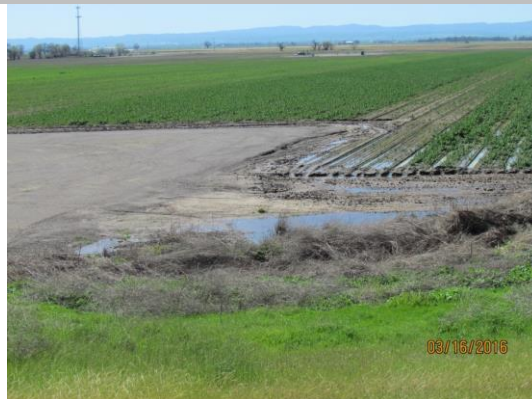
Photo 1 of 1 : FA_2016_NA0016_435_216_20160913_00120.jpg

LM Start	37.81	Rating **	U	Issue No.	216
LM End	37.81	Issue Type +	Ob	Location *	LS
Category	Earthen Levee			GPS Latitude/Longitude	
				Start	End
Item	Seepage / Sandboils			39.127945 °	39.127945 °
				-121.929831 °	-121.929831 °
DWR ID	DWR_NA0016_01_s_2016_216				
Comment Code					
Inspector Comment					
LMA is monitoring the seepage.

View of the seepage on the landward side of the levee. Spring 2016.

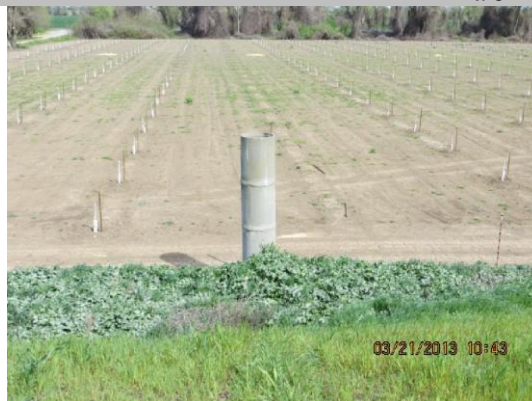
Photo 1 of 2 : UCIP_FA_2016_10528_17854.jpg

LM Start	39.93	Rating **	M	Issue No.	1579
LM End	39.93	Issue Type +	En	Location *	LS
Category	Supplemental			GPS Latitude/Longitude	
				Start	End
Item	DWR UCIP Field Study			39.143387 °	39.143387 °
				-121.927196 °	-121.927196 °
DWR ID					
Comment Code					
Inspector Comment					
FS_ID:10528 DS_ID:20282 EP_NO: 9352 Repair Type: Non-Urgent Crossing Status: Found UCIP Comments: Pipe appears to have been removed from levee section. Need to verify pipe abandonment. FIELD_STRUCT_DESC: 12-inch steel pipe through levee 5.0 feet below crown. Switch house on waterward shoulder, pump and gate valve on waterward bank. Concrete discharge standpipe on landward side. Permit was for a 14-inch (Permit No. 635, 1935). Included in the 1960 O&M manual and ABO No. 9351. FS Date: 3/21/2013

Concrete standpipe at LS toe.

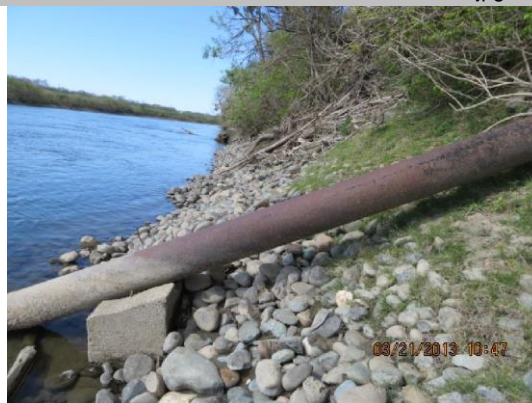
Photo 2 of 2 : UCIP_FA_2016_10528_17853.jpg

Pipe visible at WS toe.

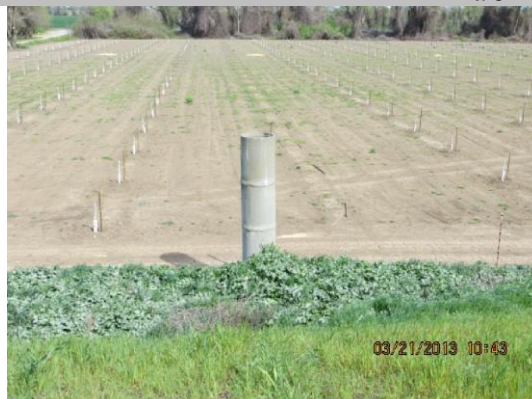
Photo 1 of 2 : UCIP_FA_2016_11343_18741.jpg

FS_ID:11343
DS_ID:22966
EP_NO: 9352
Repair Type: Non-Urgent
Crossing Status: Found
UCIP Comments: Pipe should be removed.
FIELD_STRUCT_DESC: 1.5-inch galvanized iron electrical conduit through the levee at unknown depth. Visible on WS slope (Permit No. 635, 1935).
FS Date: 3/21/2013

Electrical conduit approximately perpendicular to concrete riser on LS toe.

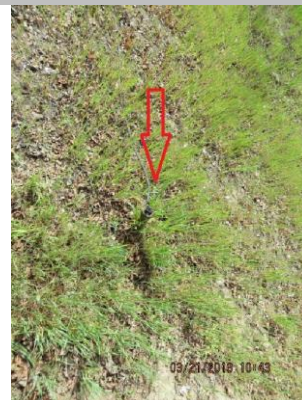
Photo 2 of 2 : UCIP_FA_2016_11343_18740.jpg

1.5-inch electrical conduit on WS slope.

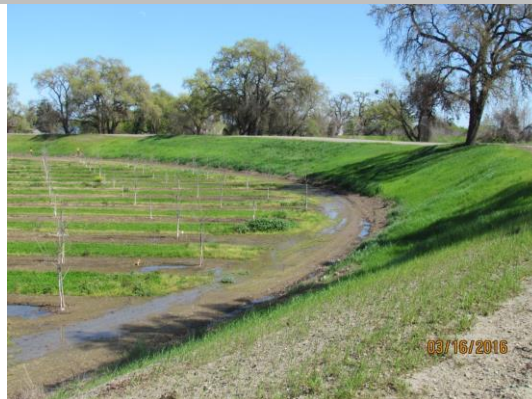
Photo 1 of 1 : FA_2016_NA0016_435_220_20160913_00121.jpg

LM Start	40.23	Rating **	U	Issue No.	220
LM End	40.29	Issue Type +	Ob	Location *	LS
Category	Earthen Levee			GPS Latitude/Longitude	
				Start	End
Item	Seepage / Sandboils			39.142304 °	39.142142 °
				-121.921861 °	-121.920833 °
DWR ID	DWR_NA0016_01_s_2016_220				
Comment Code					
Inspector Comment					
LMA is monitoring seepage site.

View of the seepage on the landward side of the levee looking upstream. Spring 2016.

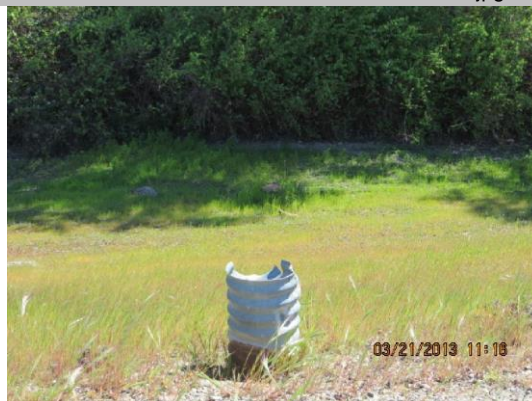
Photo 1 of 2 : UCIP_FA_2016_10527_17850.jpg

LM Start	40.44	Rating **	M	Issue No.	1578
LM End	40.44	Issue Type +	En	Location *	LS
Category	Supplemental			GPS Latitude/Longitude	
				Start	End
Item	DWR UCIP Field Study			39.143838 °	39.143838 °
				-121.919338 °	-121.919338 °
DWR ID					
Comment Code					
Inspector Comment					
FS_ID:10527					
DS_ID:20285					
EP_NO: 12799					
Repair Type: Non-Urgent					
Crossing Status: Found					
UCIP Comments: Pipe appears abandoned. Need to verify type of abandonment					
FIELD_STRUCT_DESC: 18-inch steel pipe through levee 6.5 feet below crown. 30-inch CMP standpipe on LS toe. Pump on the waterward toe. Vent in 12-inch CMP riser on the WS shoulder. (Permit No. 12799, 1979).					
FS Date: 3/21/2013

Vent in 12-inch CMP riser on WS shoulder.

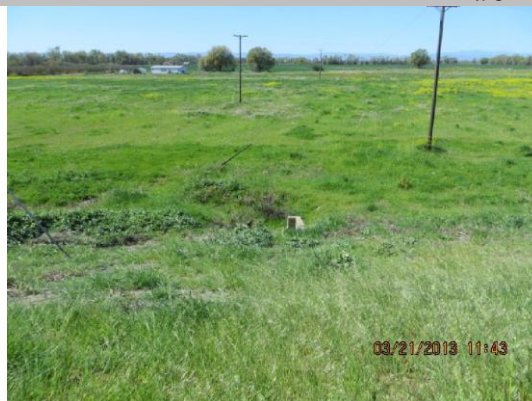
Photo 1 of 2 : UCIP_FA_2016_10533_17865.jpg

LM Start	40.89	Rating **	M	Issue No.	1583
LM End	40.89	Issue Type +	En	Location *	LS
Category	Supplemental			GPS Latitude/Longitude	
				Start	End
Item	DWR UCIP Field Study			39.150054 °	39.150054 °
				-121.918717 °	-121.918717 °
DWR ID					
Comment Code					
Inspector Comment					
FS_ID:10533 DS_ID:20287 EP_NO: 9351 Repair Type: Non-Urgent Crossing Status: Found UCIP Comments: Appears abandoned. Should be abandoned properly. FIELD_STRUCT_DESC: 30-inch corrugated metal pipe through levee 17.5 feet below crown. Slide gate on the waterward end. Discharges into concrete box at the landward toe (ABO No. 9351, 1960). Small pump discharges into sump area in front of slide gate at WS toe. FS Date: 3/21/2013

Demolished concrete distribution box at LS toe.

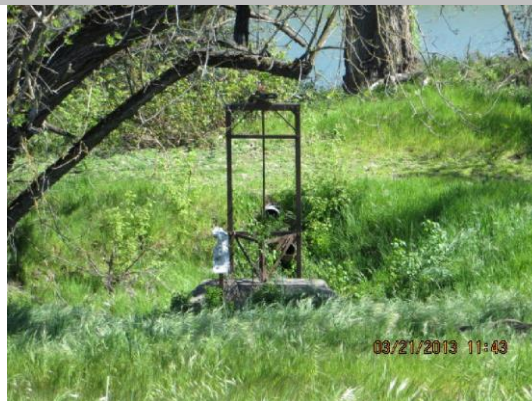
Photo 2 of 2 : UCIP_FA_2016_10533_17864.jpg

Slide gate at WS toe.

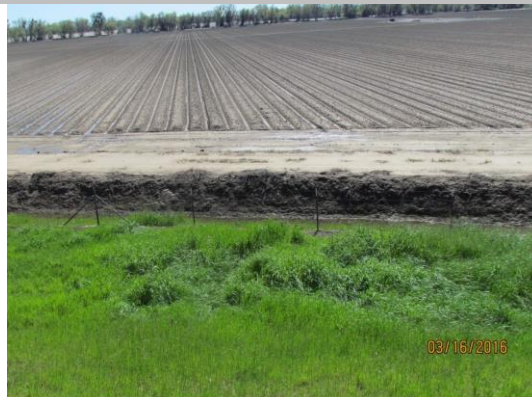
Photo 1 of 1 : FA_2016_NA0016_435_222_20160913_00122.jpg

LM Start	41.60	Rating **	U	Issue No.	222
LM End	41.64	Issue Type +	Ob	Location *	LS
Category	Earthen Levee			GPS Latitude/Longitude	
				Start	End
Item	Seepage / Sandboils			39.156913 °	39.157074 °
				-121.928324 °	-121.928964 °
DWR ID	DWR_NA0016_01_s_2016_222				
Comment Code					
Inspector Comment					
Seepage is being monitored by LMA.

View of the seepage in the ditch at the toe of the levee on the landward side. Spring 2016.

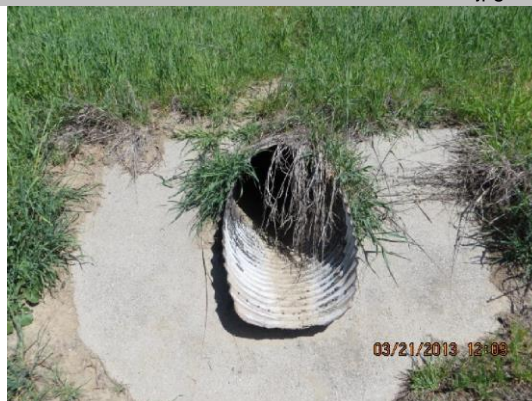
Photo 1 of 2 : UCIP_FA_2016_10536_17883.jpg

LM Start	41.86	Rating **	M	Issue No.	1584
LM End	41.86	Issue Type +	En	Location *	LS
Category	Supplemental			GPS Latitude/Longitude	
				Start	End
Item	DWR UCIP Field Study			39.158648 °	39.158648 °
				-121.932429 °	-121.932429 °
DWR ID					
Comment Code					
Inspector Comment					
FS_ID:10536					
DS_ID:20289					
EP_NO: 9341					
Repair Type: Non-Urgent					
Crossing Status: Found					
UCIP Comments: Appears abandoned. Needs to be abandoned properly.					
FIELD_STRUCT_DESC: 30-inch pipe through levee 19.5 feet below crown. Slide gate in 36-inch corrugated metal pipe riser on the waterward slope (ABO No. 9341, 1960)					
FS Date: 3/21/2013

30-inch CMP at outlet on LS toe.

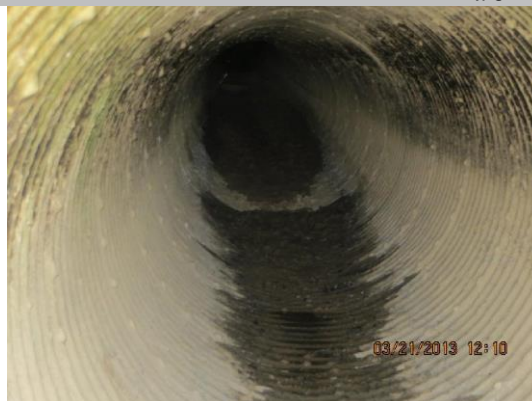
Photo 2 of 2 : UCIP_FA_2016_10536_17882.jpg

LM Start	41.86	Rating **	M	Issue No.	1584 (cont)
LM End	41.86	Issue Type +	En	Location *	LS
Category	Supplemental			GPS Latitude/Longitude	
				Start	End
Item	DWR UCIP Field Study			39.158648 °	39.158648 °
				-121.932429 °	-121.932429 °
DWR ID					
Comment Code					
Inspector Comment					
FS_ID:10536 DS_ID:20289 EP_NO: 9341 Repair Type: Non-Urgent Crossing Status: Found UCIP Comments: Appears abandoned. Needs to be abandoned properly. FIELD_STRUCT_DESC: 30-inch pipe through levee 19.5 feet below crown. Slide gate in 36-inch corrugated metal pipe riser on the waterward slope (ABO No. 9341, 1960) FS Date: 3/21/2013

View from LS toe of CMP pipe.

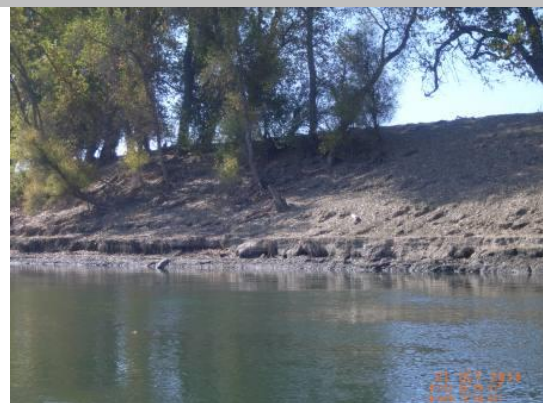
Photo 1 of 1 : FA_2016_NA0016_435_4_20160913_00004.jpg

LM Start	42.90	Rating **	A/W	Issue No.	4
LM End	43.09	Issue Type +	Ma	Location *	WS
Category	Supplemental			GPS Latitude/Longitude	
				Start	End
Item	2015 USACE Erosion Survey, DRAFT			39.172501 °	39.174949 °
				-121.939053 °	-121.940737 °
DWR ID	DWR_NA0016_01_s_2016_4				
Comment Code					
Inspector Comment					
2010 - Lower portion of 136.7 that did not extend far enough. Abrupt transition from upstream site. 2012 - Site extended upstream, minor new erosion. 2013 - Minor new erosion at the toe. New tree popout. Downstream limit extended. 2015: No observed changes. [2015 Site ID: SAC_136-6_R]

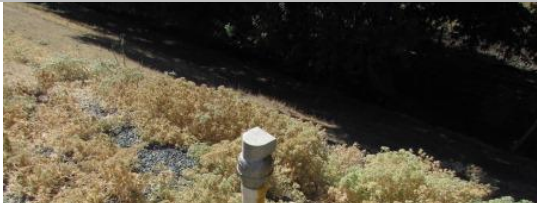
Photo 1 of 1 : FA_2016_NA0016_435_97_20160929_00252.jpg

View of pipe riser on landside slope near the crown of the levee. Fall 2016 inspection.

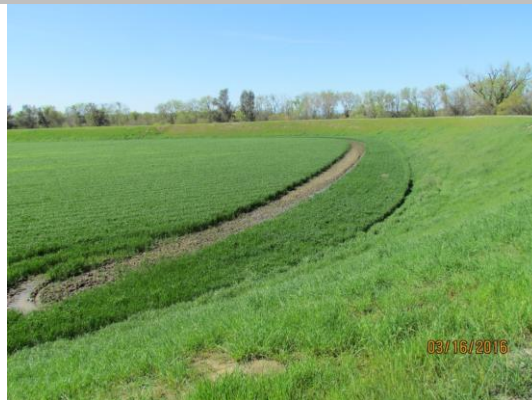
Photo 1 of 1 : FA_2016_NA0016_435_228_20160913_00125.jpg

LM Start	44.87	Rating **	U	Issue No.	228
LM End	45.23	Issue Type +	Ob	Location *	LS
Category	Earthen Levee			GPS Latitude/Longitude	
				Start	End
Item	Seepage / Sandboils			39.195595 °	39.193890 °
				-121.945408 °	-121.950276 °
DWR ID	DWR_NA0016_01_s_2016_228				
Comment Code					
Inspector Comment					
Seepage site is being monitored by LMA.

View of the seepage on the landward side of the levee looking upstream.
Spring 2016.

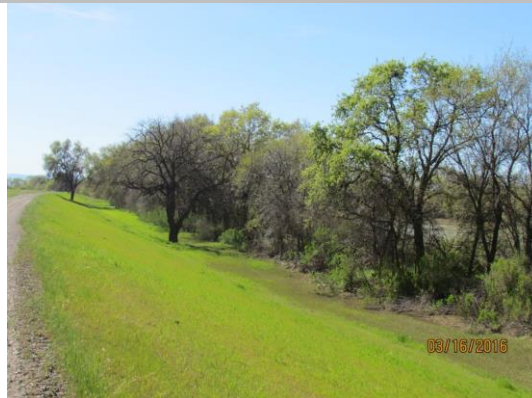
Photo 1 of 2 : FA_2016_NA0016_435_108_20160913_00046.jpg

LM Start	45.39	Rating **	A/W	Issue No.	108
LM End	45.90	Issue Type +	Ob	Location *	WS
Category	Earthen Levee			GPS Latitude/Longitude	
				Start	End
Item	Vegetation			39.192653 °	39.188518 °
				-121.952768 °	-121.960446 °
DWR ID	DWR_NA0016_01_s_2015_108				
Comment Code					
V8 : Environmental Requirements.					
Inspector Comment

View of the revegetation site on the waterward side of the levee looking upstream. Spring 2016.

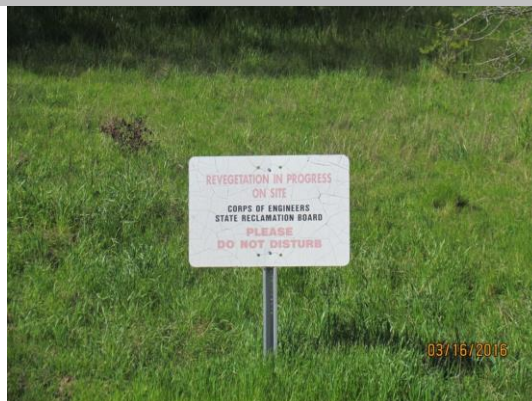
Photo 2 of 2 : FA_2016_NA0016_435_108_20160913_00047.jpg

Sign stating revegetation site. Spring 2016.

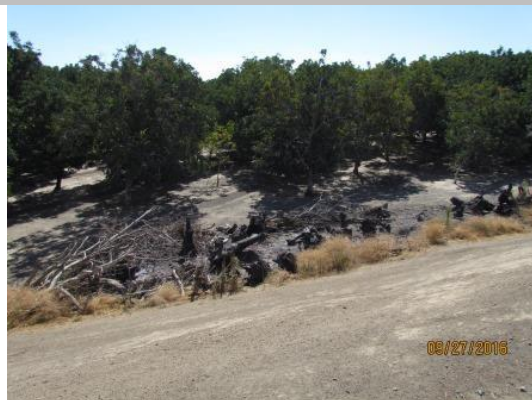
Photo 1 of 1 : FA_2016_NA0016_435_105_20161003_00254.jpg

LM Start	45.90	Rating **	M	Issue No.	105
LM End	45.90	Issue Type +	En	Location *	LS
Category	Earthen Levee			GPS Latitude/Longitude	
				Start	End
Item	Encroachments			39.188469 °	39.188469 °
				-121.960428 °	-121.960428 °
DWR ID	DWR_NA0016_01_f_2016_105				
Comment Code					
TR : Tree or limb					
Inspector Comment

View of debris within 10 feet of landside toe. Fall 2016 inspection.
